## **Limited Visual Dam Safety Inspections**

**OA00045**

**Helemano 16 Reservoir**

**May 2006**

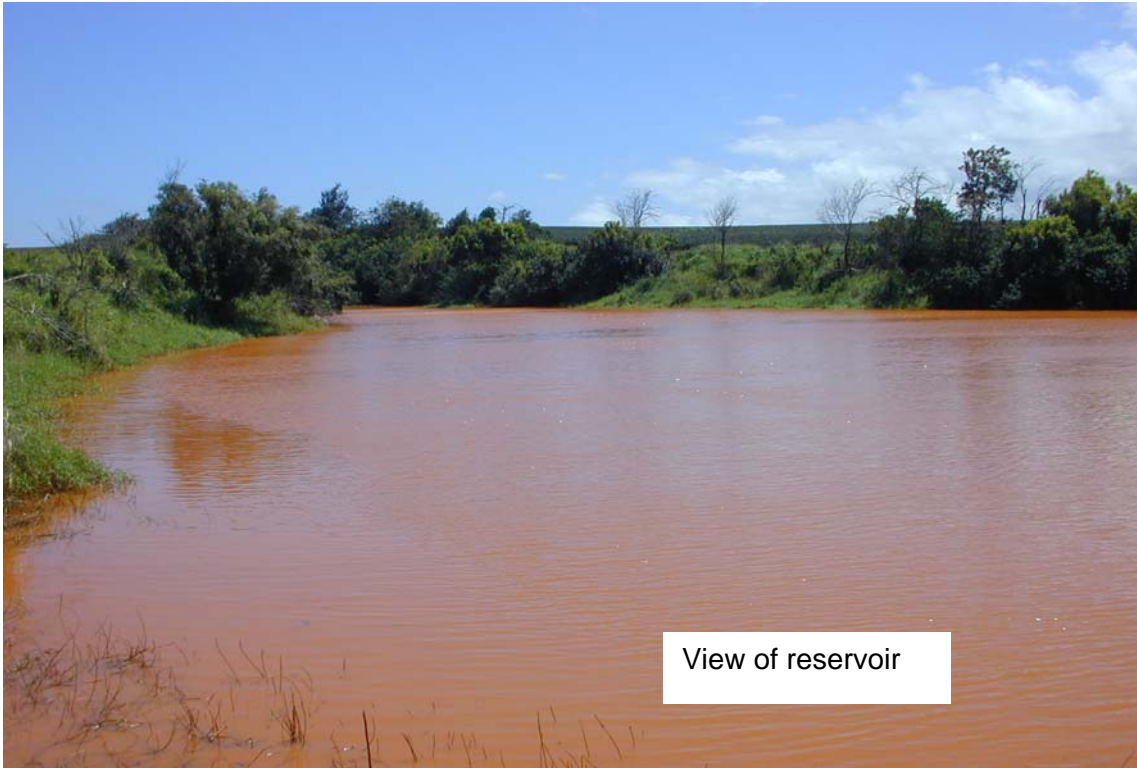
View of reservoir

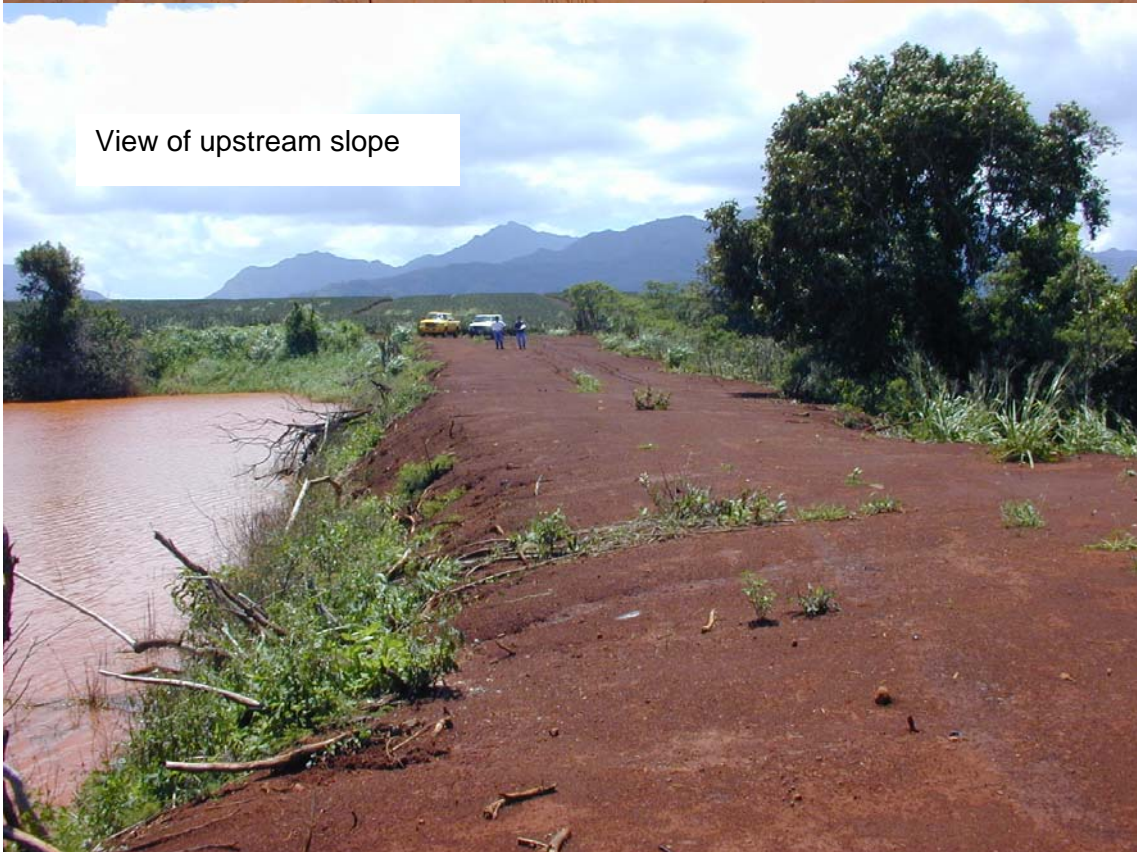
- a. The upstream slope was not fully inspected due to heavy vegetation.
- b. The upstream slope appeared to be in fair to poor condition and requires corrective action.
- c. The upstream slope was not visible due to high grass and bush vegetation. Clear high vegetation and maintain low to enable easy visual inspection.

View of upstream slope

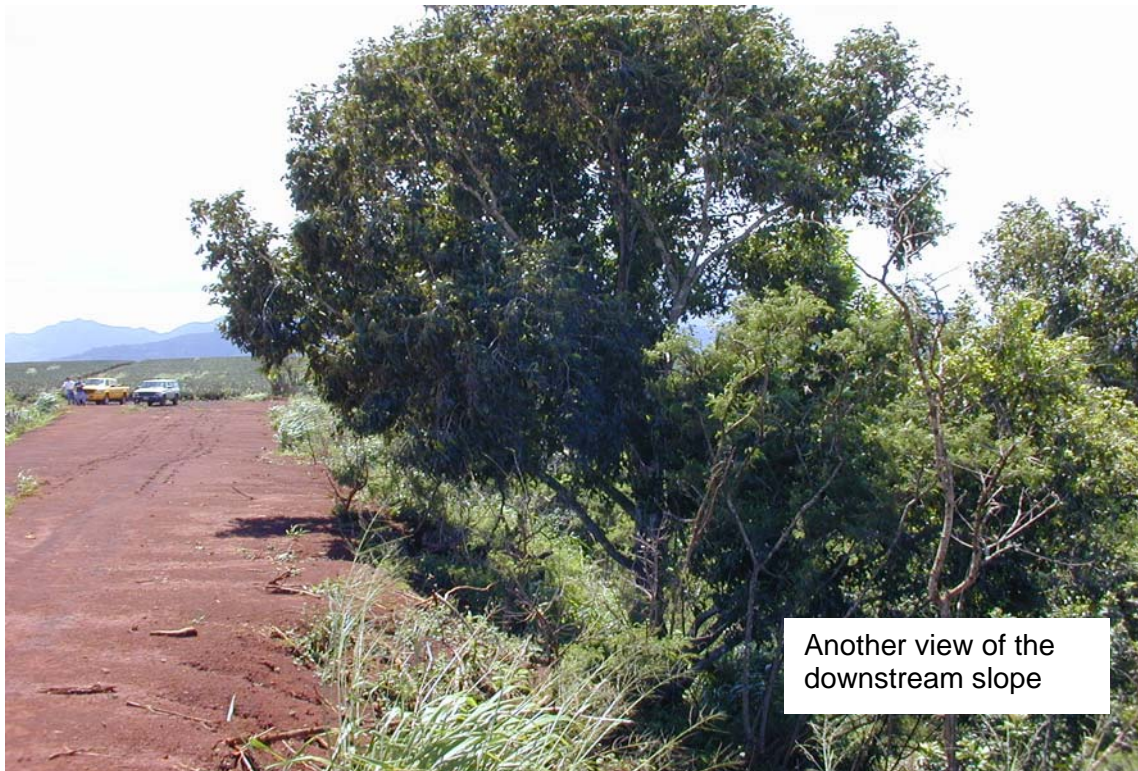
The downstream slope was in fair condition and not visible for the most part due to heavy vegetation. The slope was very steep, around a 1V to 1H slope or steeper.

Erosion was not observed on the downstream slope, however the slope was not entirely visible. Cracks were observed perpendicular to crest.

Another view of the downstream slope

- a. The downstream slope appeared to be in fair condition and requires evaluation.
- b. Slope protection needs maintenance or repair. Description: Downstream slope ½:1 should be evaluated.

- c. A crack was observed on the slope, which requires further investigation to determine the underlining cause. Monitor the area and / or repair as required.

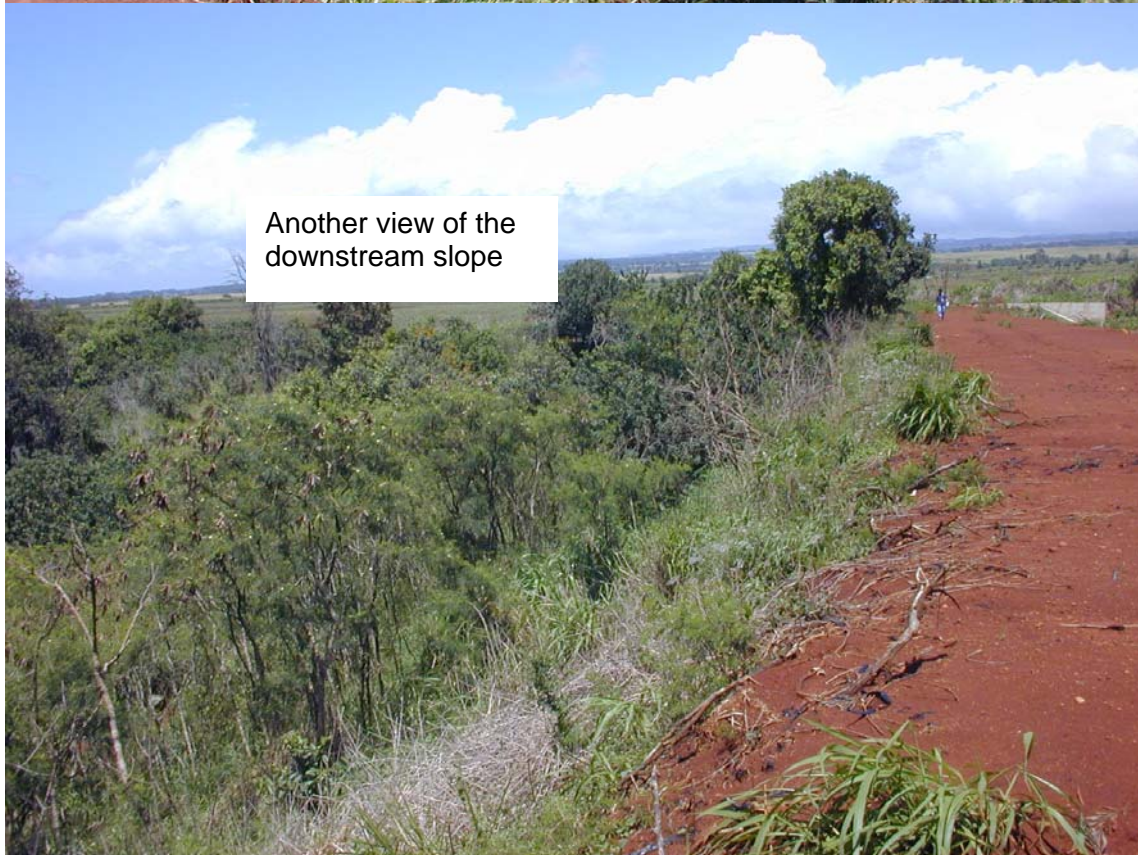
Another view of the downstream slope

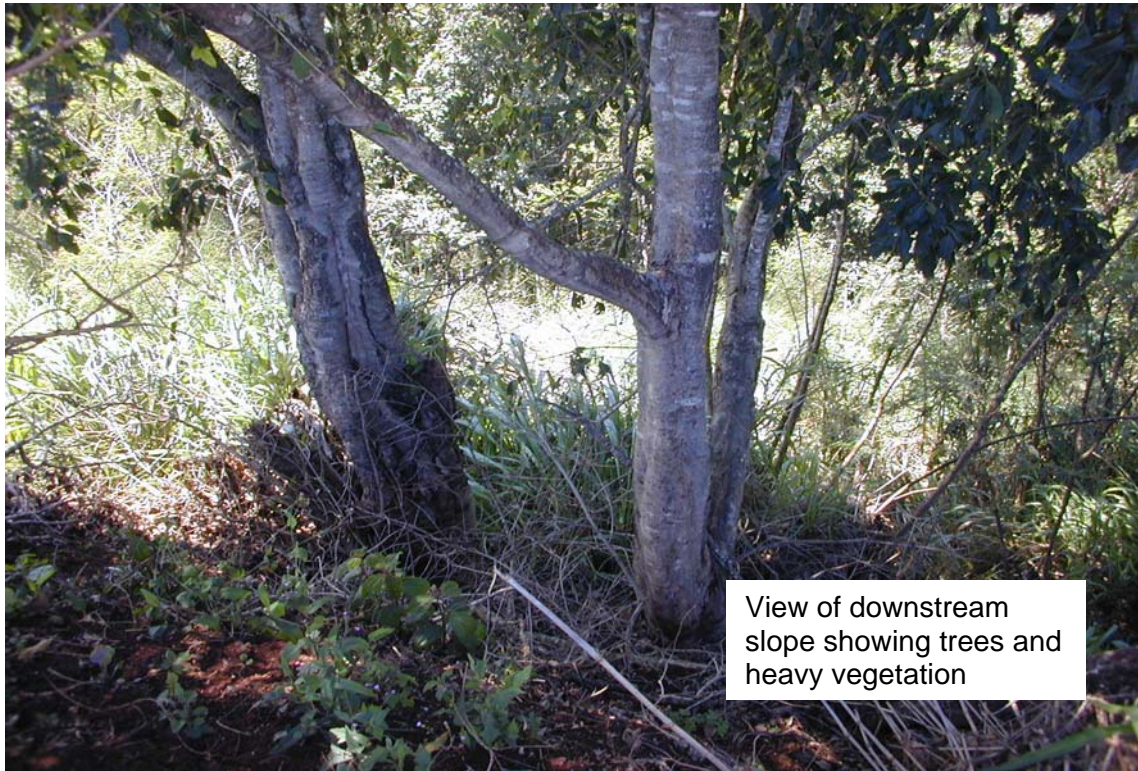
Vegetation was observed on the downstream slope. The majority of the vegetation was bushes with some woody trees.

View of downstream slope showing trees and heavy vegetation

- e. Tree(s) were observed on the downstream slope. Trees have been identified as the probably cause of piping failures, and can possibly cause severe damage to the embankment if they are uprooted during a high winds. Corrective action is required to remove the tree hazards from the dam. Acceptable remedies include removal of the tree and its root structure down to a 2" diameter and reconstructing the damaged embankment section. All repair work shall be accomplished as per the requirements of licensed geotechnical or structural engineer. Routinely monitor the damaged area for signs of settlement and seepage.

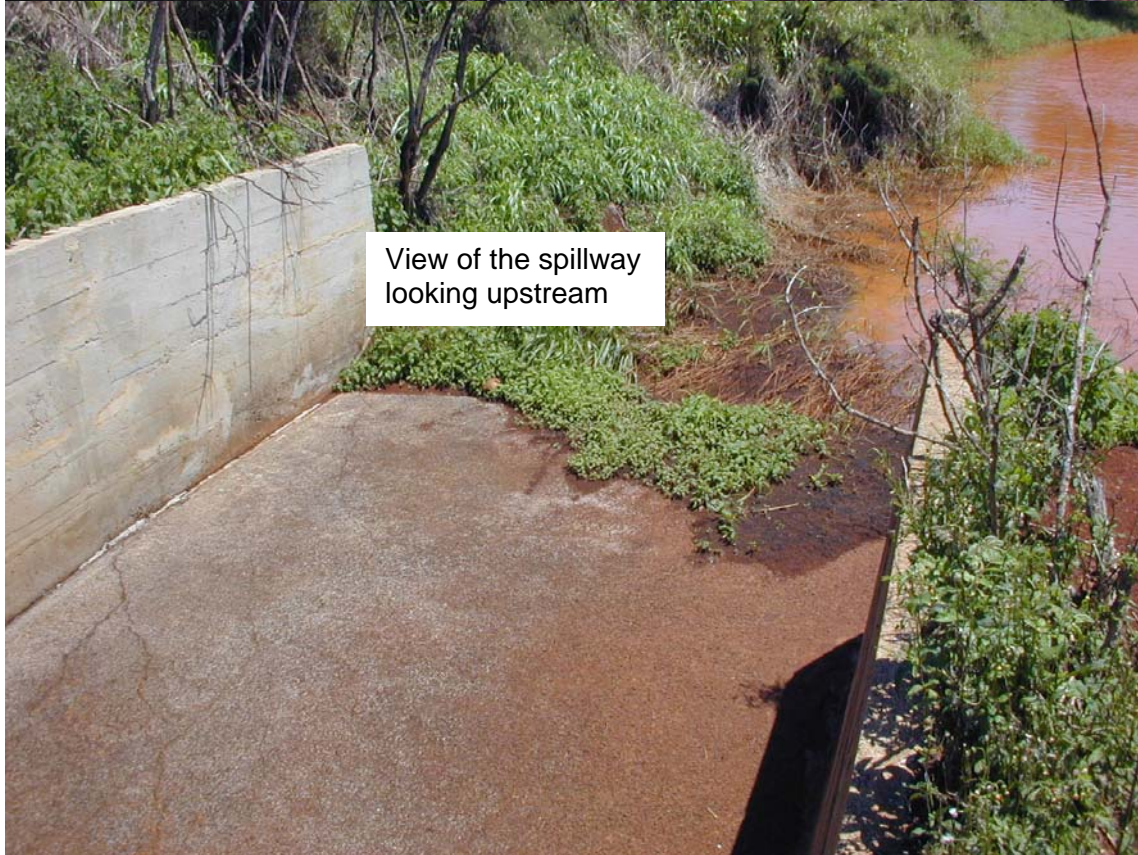
View of the spillway looking upstream

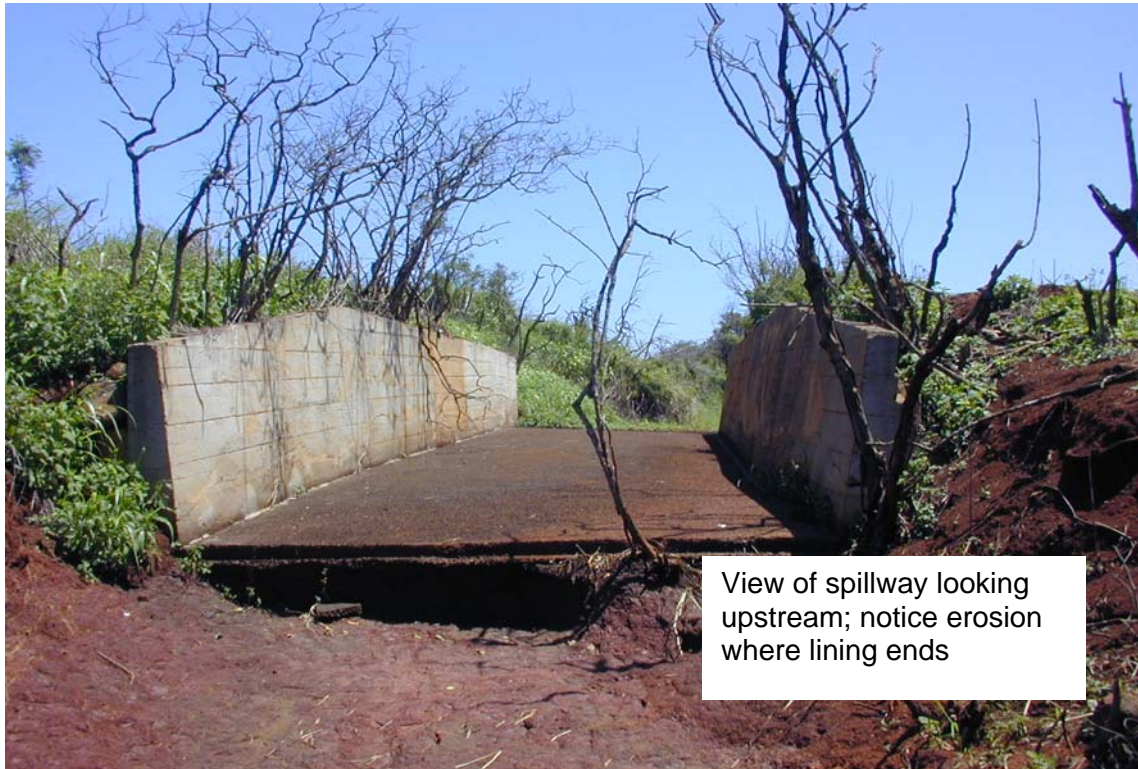
Erosion observed near the spillway.

- a. The Spillway appeared to be in fair to poor condition and requires corrective action.

View of spillway looking upstream; notice erosion where lining ends

- b. Slope protection needs maintenance or repair. Description: Provide protection against erosion observed.
- c. The spillway approach was partially blocked with vegetation. Clear approach.
- d. Severe scour erosion was observed which requires maintenance and/or repair. Description: Erosion observed at downstream end of the lined spillway.
- e. Unclear if spillway is adequately sized. Spillway should pass the probable maximum flood. Verify spillway capacity and take corrective action as required.

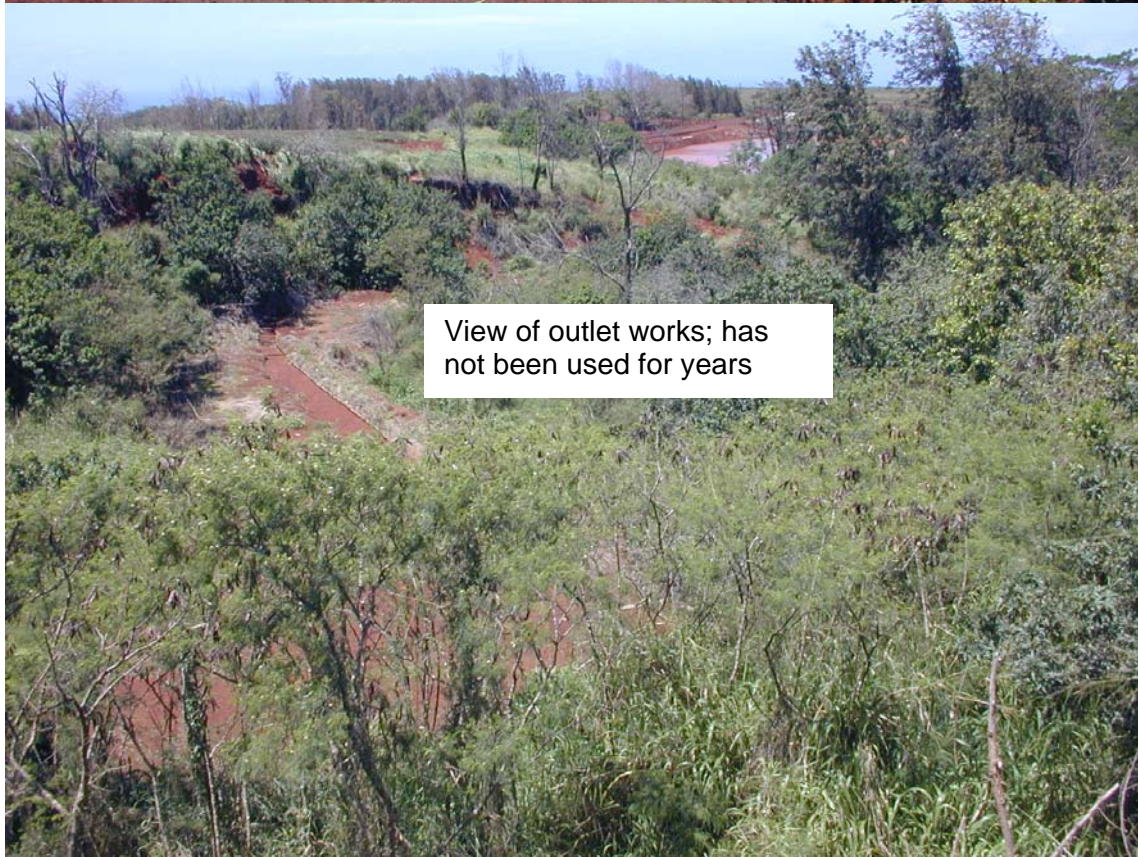
- a. The outlet works were not inspected.
- b. The outlet works were not tested.
- c. The outlet works appeared to be in fair to poor condition and requires corrective action.
- d. Operability of outlet works should be verified.

View of outlet works; has not been used for years
